Conditions Assessment Report

Newfane Railroad Depot

Cemetery Hill Road
Newfane, Windham County, Vermont

November 2014

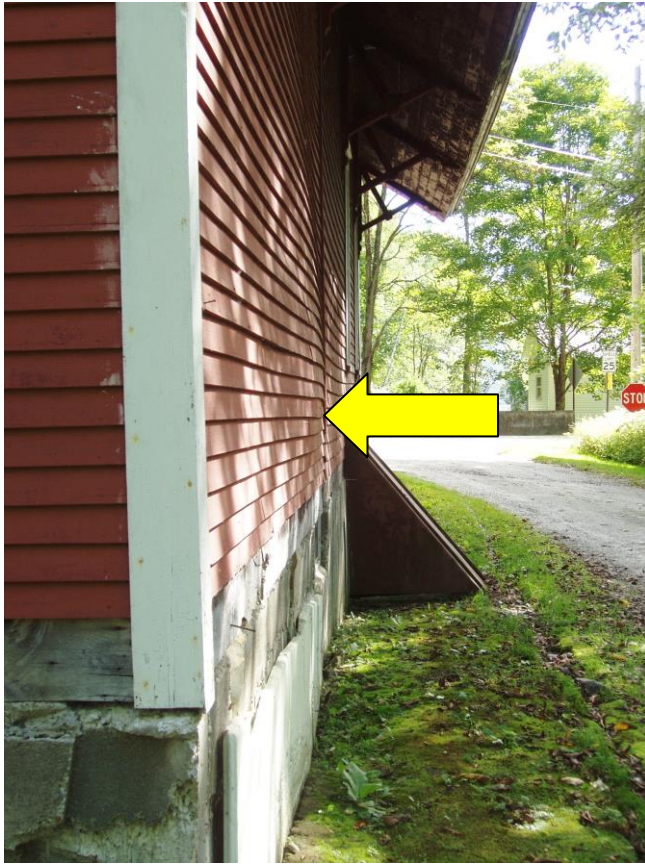
Depending on the location of grade along the east elevation, this wall's sill plate is either too close to grade or below grade, and it is undergoing water damage. The rest of the sill plate is covered with wood boards and could not be examined from the exterior. From the cellar, rot is visible at the sill in sections along the east elevation. There are three rows of cut joists at the northeast corner of the cellar, and a hodgepodge of insufficient vertical supports under the floor joists. There is a bulge in the wall at the left end of the west elevation, possibly caused by the misalignment of the new foundation with the wall.

Facing south toward west elevation, yellow arrow points to bulge in wall

Repair floor structure
Replace flooring in baggage/freight room
Repair bulge in west wall

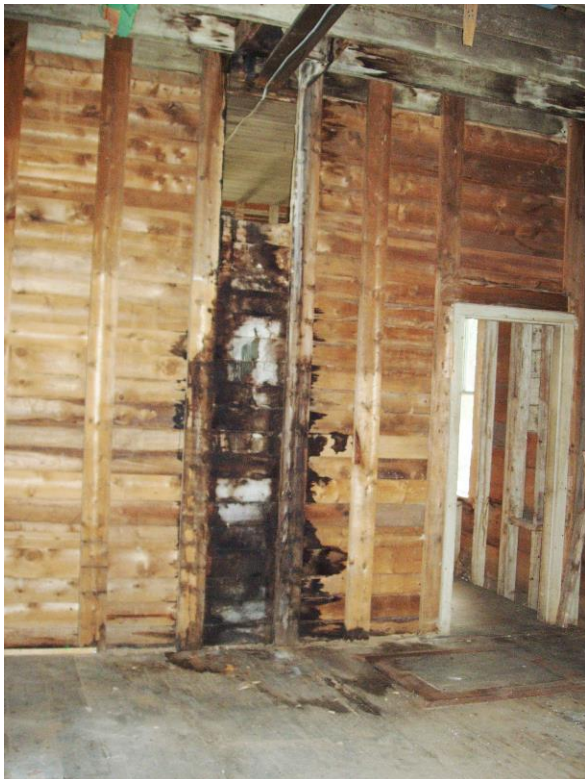
Moisture damage is also visible at the corners of the roof, mostly at the exterior under the overhangs but also at the north end's interior roof corners. Water damage caused by extensive moisture infiltration is visible in the location of the former chimney, as seen in the baggage/freight room.

Facing south in baggage room toward location of former chimney

The exposed structure should remain exposed, as this is the historic appearance of the room and conveys its utilitarian use. The water-stained and rotted wood elements in the location of the chimney should be replaced in-kind. The flooring may be replaced with wide, rough-plank wood flooring to match existing. The scale and platform should be retained.

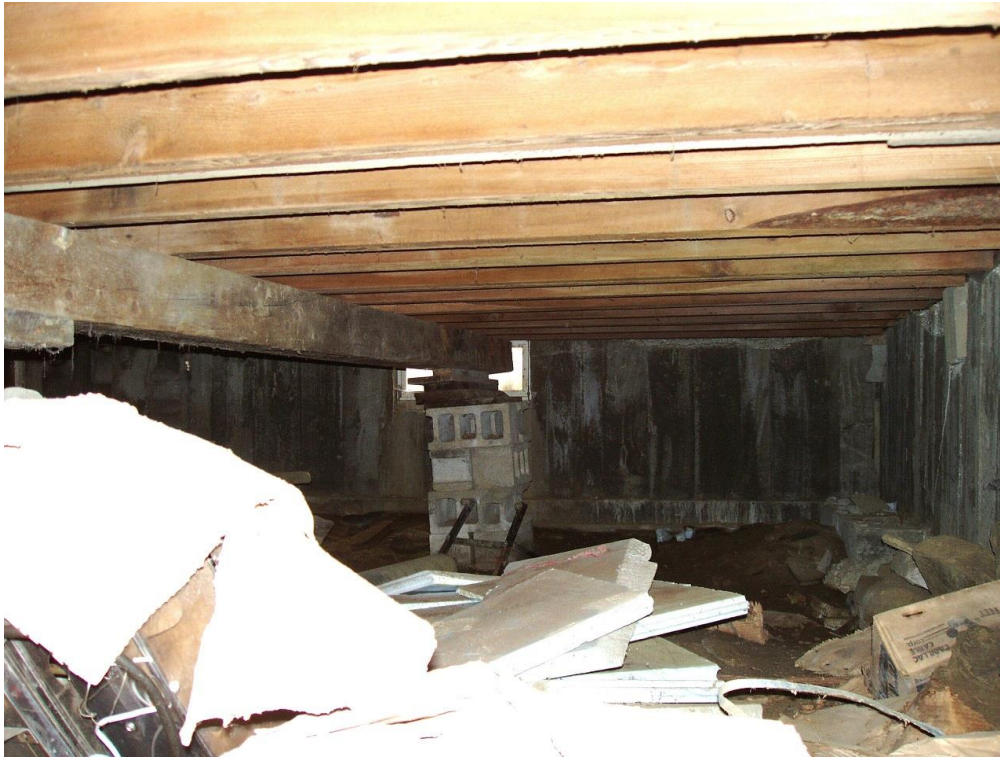
Facing south from bulkhead. Note insufficient beam support.

The cut floor joists in the northeast corner should be repaired. A centered longitudinal support beam should be installed under the floor structure, and the hodgepodge vertical supports in the cellar should be removed. Since it is easier to perform this work from above, and the flooring in the baggage/freight room is damaged beyond repair, sections of the flooring could be removed to perform the repair work.

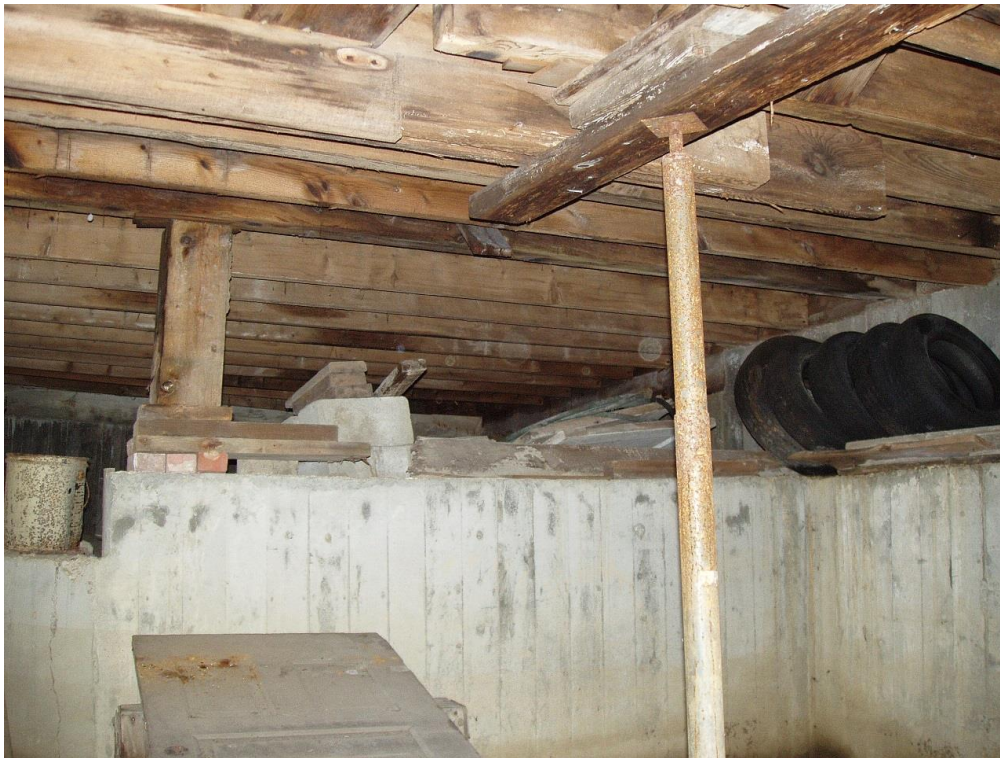
Facing northeast from bulkhead. Note insufficient beam support.

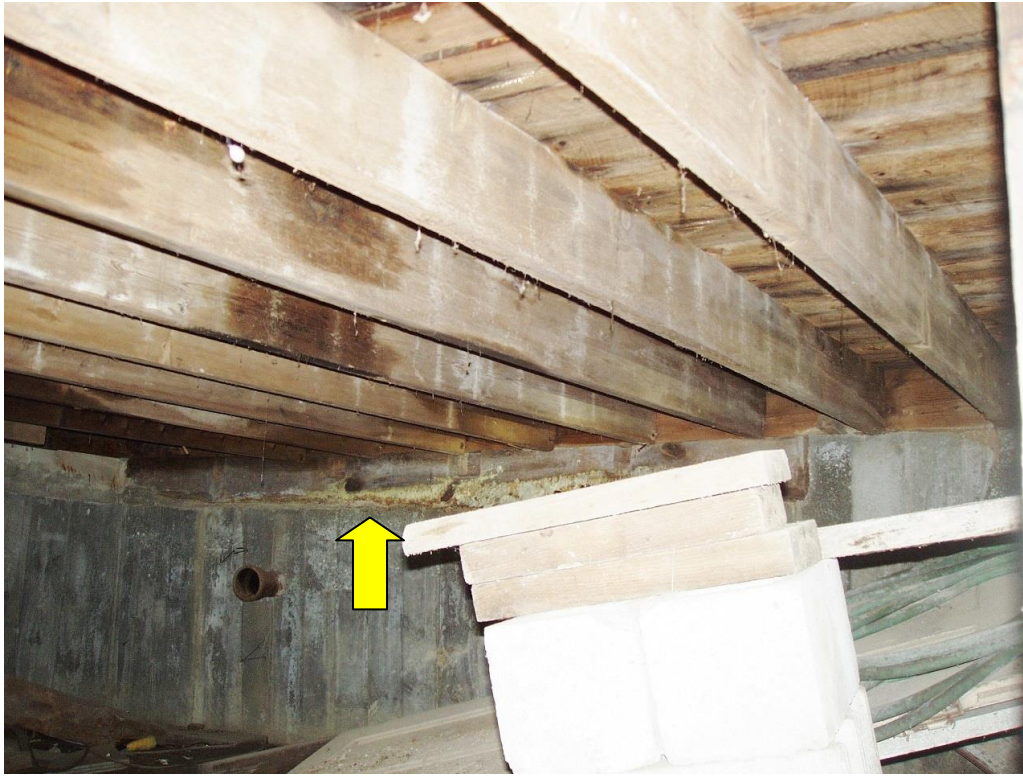
Facing east from bulkhead. Yellow arrow points to damaged section of sill.

Damaged sections of the east sill should be repaired or replaced, and this work should occur in coordination with the grade excavation work, when the grade is lowered to below the east sill. The sill could be pressure-treated, if it will be concealed by a full façade platform, or a historically-accurate rough sawn timber sill.

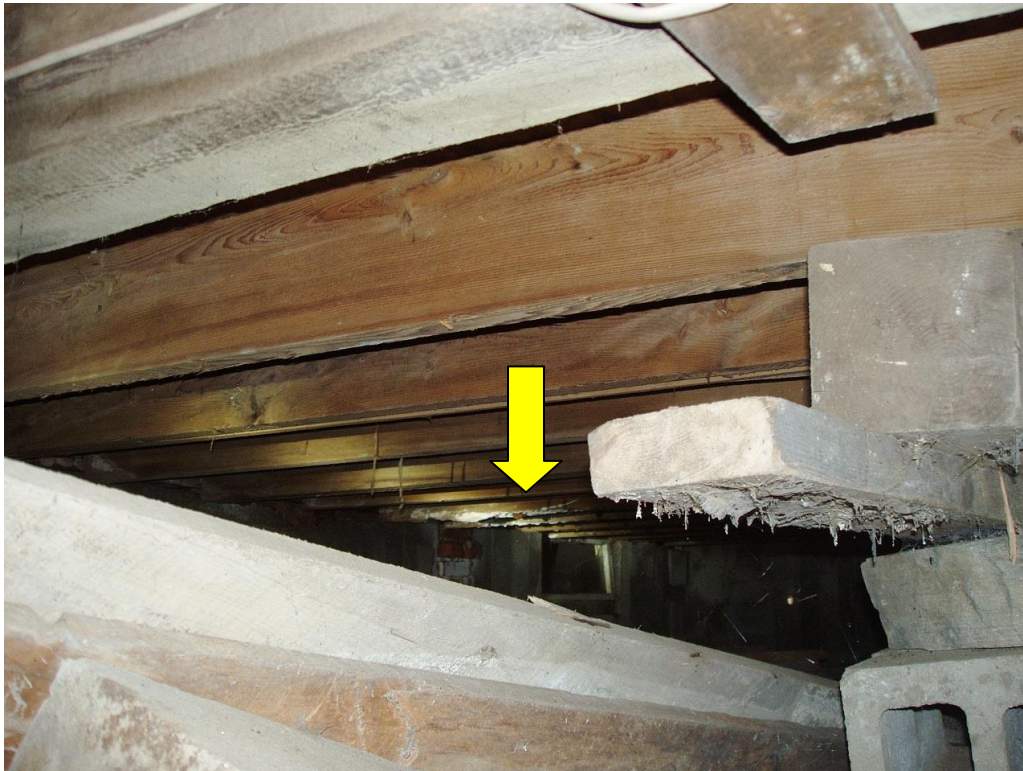
Facing southeast from bulkhead. Yellow arrow points to damaged sections of joists.
