Conditions Assessment Report

Newfane Railroad Depot

Cemetery Hill Road
Newfane, Windham County, Vermont

November 2014

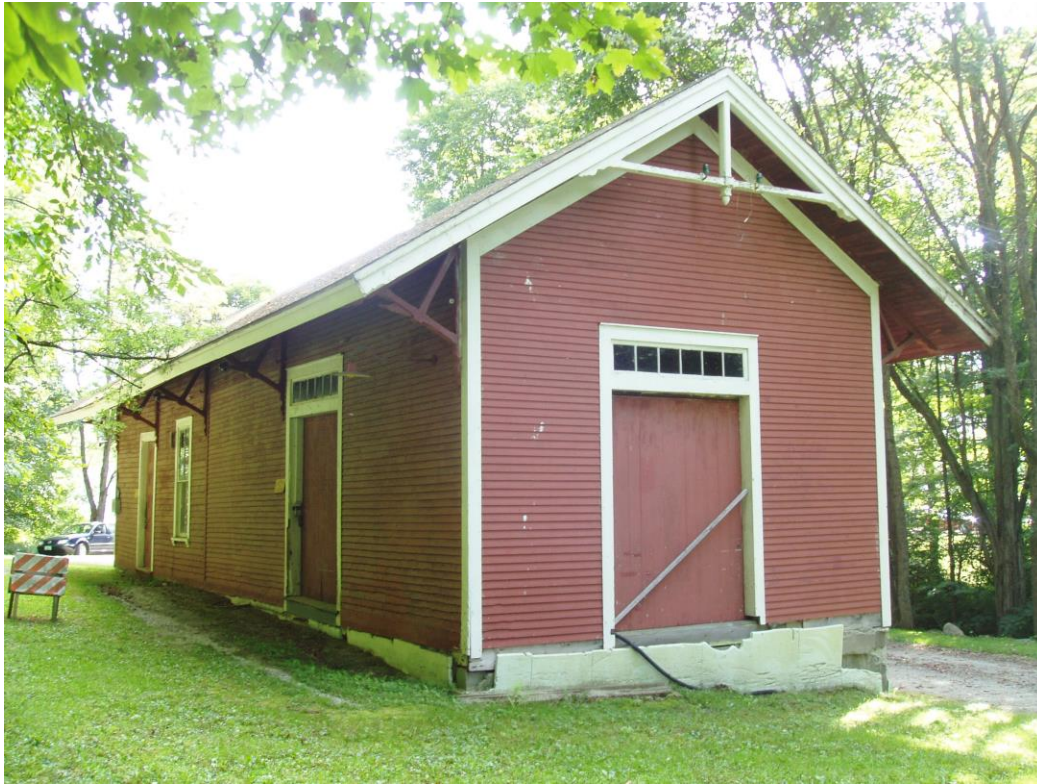
Facing southwest toward east and north elevations

The east-west grade descent, and water drainage off the roof, have caused erosion at the east side of the building and a resulting negative slope of grade toward the foundation. This allows water to collect along the foundation and penetrate the foundation into the cellar. This not only causes damage to the foundation, but the moisture in the cellar will eventually cause the floor structure to rot.

Depending on the location of grade along the east elevation, this wall's sill plate is either too close to grade or below grade, and it is undergoing water damage. The rest of the sill plate is covered with wood boards and could not be examined from the exterior. From the cellar, rot is visible at the sill in sections along the east elevation. There are three rows of cut joists at the northeast corner of the cellar, and a hodgepodge of insufficient vertical supports under the floor joists. There is a bulge in the wall at the left end of the west elevation, possibly caused by the misalignment of the new foundation with the wall.

- Excavate the ground at the east side of the building
- Damp-proof the foundation up to grade
- Install a footing/perimeter drain pipe
- Install 1 ½" stone at footing depth
- Install clean structural backfill to grade
- Continue drain pipe around gable ends of building
- Determine in field the necessity of continuing drainage at west side

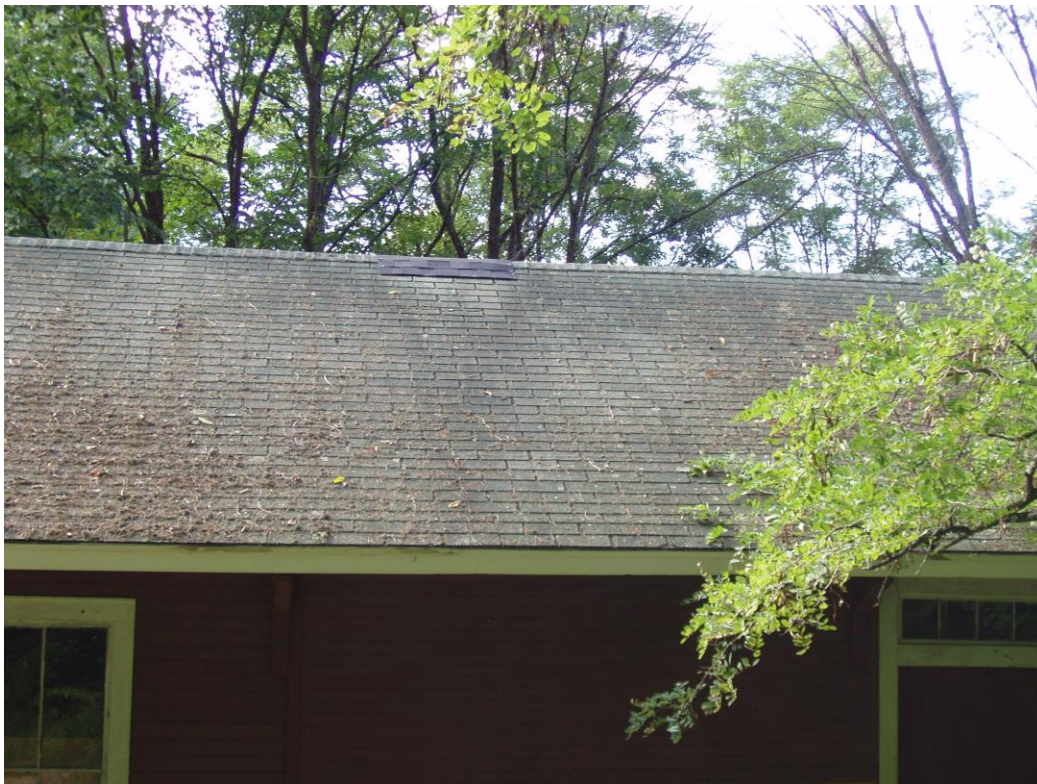
Facing west toward east roof slope

The roof has outlived its useful life and must be replaced. After it is removed, the roof sheathing should be inspected from above as there may be areas of rot.
